XB-46 AIRCRAFT, SERIAL NO. 45-59582, PNEUMATIC SYSTEM AND COMPONENTS TESTS AND INSPECTION

WADC TECHNICAL REPORT NO. 52-44

March 1952

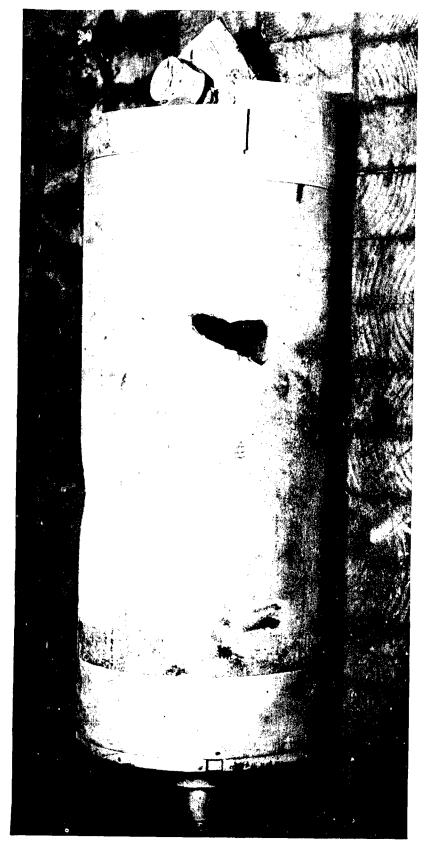
A projectile was tumbled into and pierced the aft bomb door accumulator as shown in Plate 1 of this report. Two tumbled shots on the main landing gear fork (normal brake accumulator) resulted in two partial penetrations as shown on Plate 2. A straight shot pierced the accumulator as also shown in Plate 2. A straight shot pierced the nose gear drag brace (main landing gear accumulator Part B) as shown in Plate 3, and a straight shot pierced and lodged itself in the main landing gear drag brace (main landing gear accumulator Part C) as shown in Plate 4. The projectiles made clean holes and none of the accumulators shattered, as shown in the photographs.

AFT BOMB DOOR NORMAL SYSTEM

ACCUMULA TOR, PART A

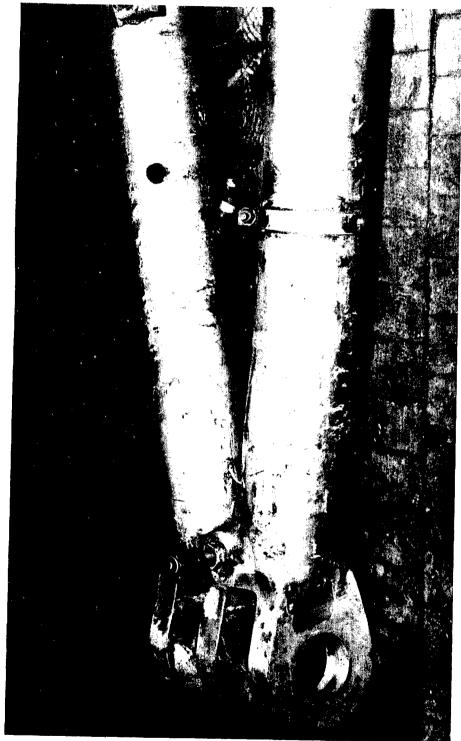
PLATE 3

NOSE GEAR DRAG BRACE, NORMAL MAIN

LANDING GEAR ACCUMULATOR PART B

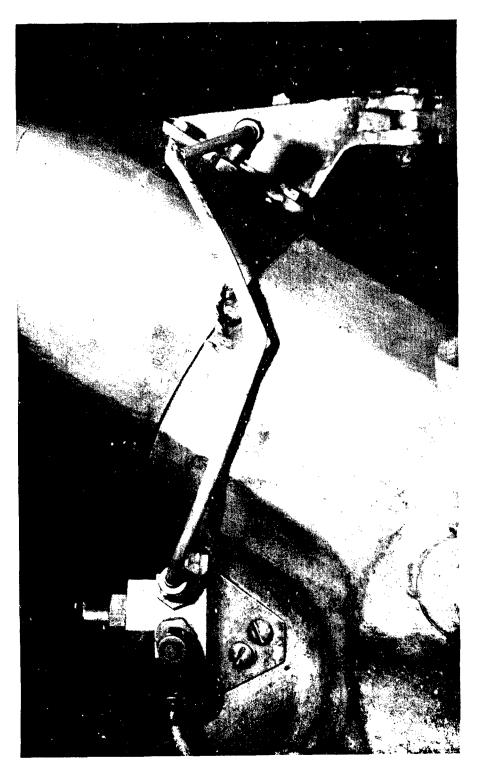
MAIN LANDING GEAR DRAG BRACE, HORMAL.

MAIN LANDING GEAR ACCUMULATOR, PART C

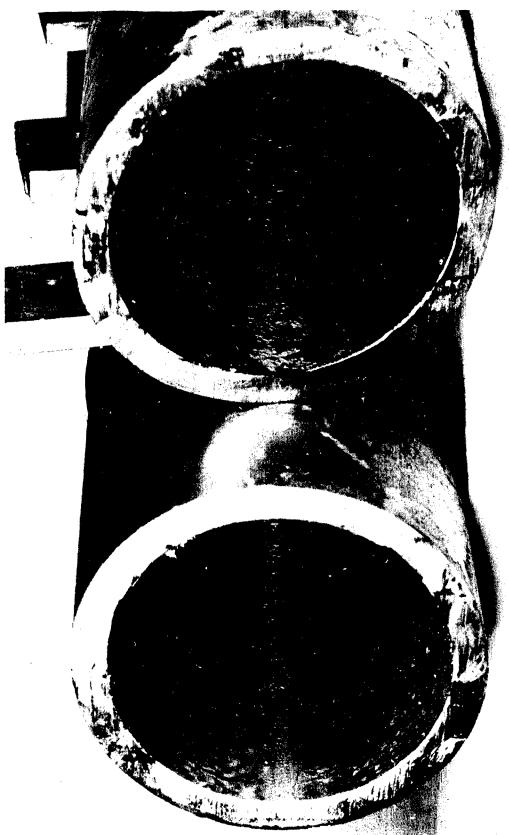
The accumulators were then cut open to check the internal surfaces as to what damage might have been done by moisture in the air. The Materials Laboratory determined that there was some surface corrosion, but it was considered very slight considering the length of time that the aircraft was in use. It was considered that the amount of corrosion present was not sufficient to cause trouble to the airplane. The projectiles knocked some of the zinc chromate coating from the inside surfaces of the landing gear accumulator as shown in Plate 5. There was some surface corrosion where the zinc chromate was knocked off.

Plate 5 END VIEW OF LEGS ON THE NORMAL MAIN LANDING

GEAR ACCUMULATOR PART NO. 109-5110102. AFTER PIERCING AND CUTTING
